A Field Report

Primary Containment – Phosphate Slurry

<p>Application of a spray on monolithic liner to the interior of the slurry suspension tank to prevent corrosion and abrasion failure.</p>
Industrial Customer:	J. R. Simplot Company
Project Location:	Vernal Phosphate Operation Vernal, UT
C&I Applicator:	Rhino Linings Industrial Division, California and Dealer applicator, Vernal, Utah
Lining Solution:	Rhino Linings Tuff Stuff, 100% solids polyurethane sprayed on lining
Lining Application System:	Rhino Linings MX-2300 Hi-Flow SprayCast System – low pressure and low temperature.

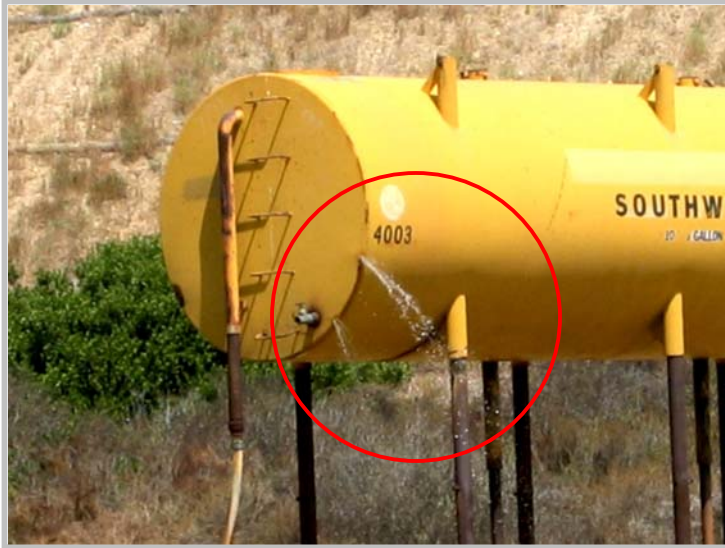
Primary storage tanks made of mild steel will eventually fail from corrosion and abrasion degradation. Owners of mild steel primary processing/storage tanks must reconcile the cost of building a replacement tank when it fails and the cost of installing a protective lining that will significantly lengthen to service life of the tank. J. R. Simplot decided to install our sprayed on monolithic lining to protect their above ground processing/storage tank.

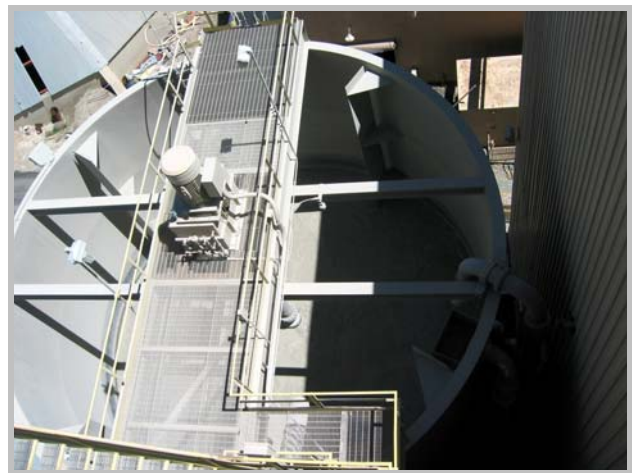
The 12,000 square foot interior of the slurry tank needed a monolithic lining installed to prevent the inevitable failure due to corrosion and abrasion. The owners considered rubber but were concerned about the adhesive performance between the rubber and the steel substrate as well as the seam integrity. They were also concerned about the long term performance of the rubber after noticing early applications of rubber showed cracking and loss of elasticity.

In addition the finished lining would be monolithic fully adhered to the entire surface of the tank interior and the long term physical performance of our lining was superior to the rubber alternative.

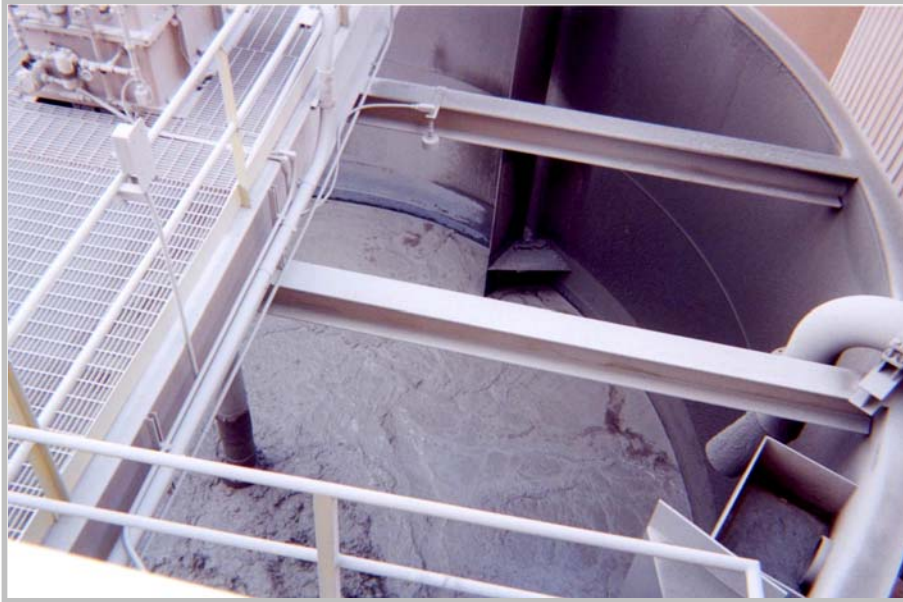
The interior of the tank was prepared according to SSPC accepted standards for linings and coatings: the mild steel substrate was cleaned of salts and other contaminants, then profiled by media blasting; the substrate was cleaned again then primed; lastly the Tuff Stuff lining was sprayed applied to the entire interior surface of the tank to a minimum thickness of 1/8".

The lining becomes tack free within one minute and the tank could be back in service after 24 hours after completion of the lining installation.

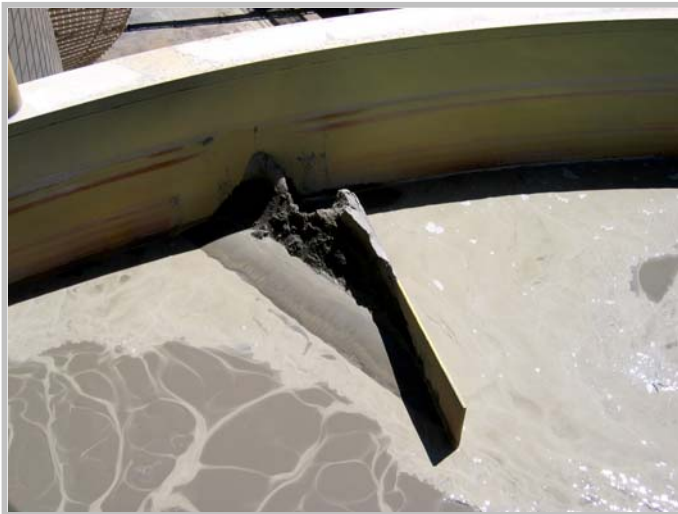
The sprayed on lining created a monolithic, impervious protective lining. In areas expected to receive more severe service, the lining thickness was increased to 1/4" – another benefit of our sprayed on lining system – each application is customized to the needs of the customer.

The lining was installed in 2001 and upon inspection 5 years later it is performing beyond the customer's expectations.
